Advanced Management Module  
Messages Guide

**Fourteenth Edition (October 2014)**

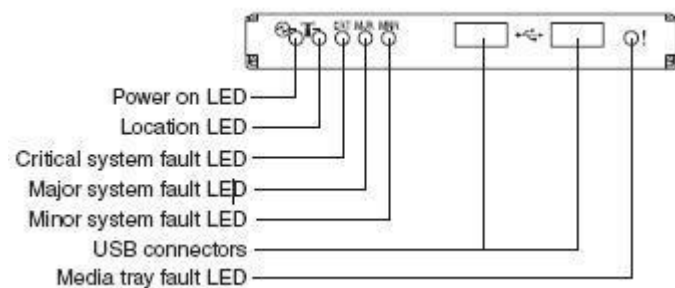
## Light path diagnostic LEDs - BladeCenter T and BladeCenter HT chassis

The system LEDs are displayed on the media tray.

The following system LEDs are displayed:
